## CASE STUDY

## OPTUS SATELLITE

The satellite structure required repairs and maintenance due to the deterioration of the existing paint system, which had resulted in corrosion to the steel structure.

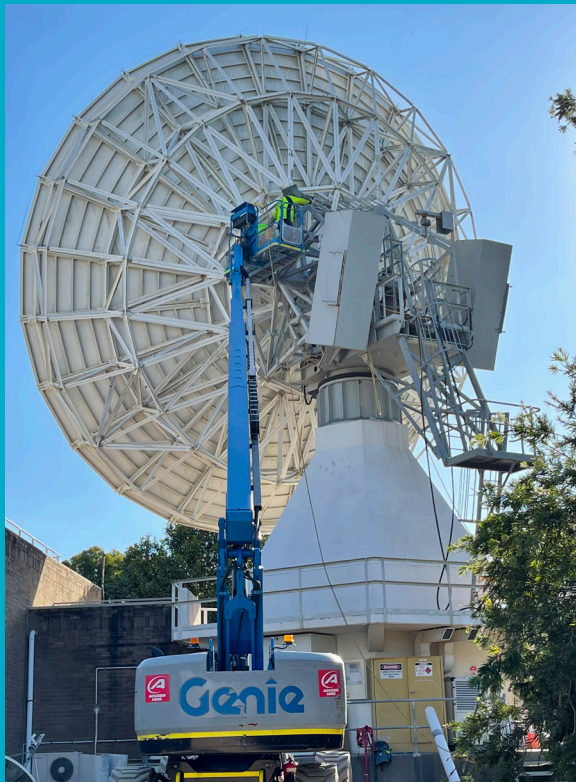
With the original paint and corrosion removed and a new protective surface applied, the structure's surface will now be maintenance-free for many years to come.

The existing painted steel was abrasive blasted to remove the old paintwork and surface corrosion. A Dulux 3 coat epoxy paint process was then applied: Dulux Zincode Primer 402, followed by Dulux Durabild STE and a top coat of Weathermax HBR.
